# ***Modular Concrete Bunker Indirect Fire Validation***

***Fort Polk, LA  
August 4<sup>th</sup> to 13<sup>th</sup>, 2004***

# **DRAF**Series 1 - Buried Emplacement

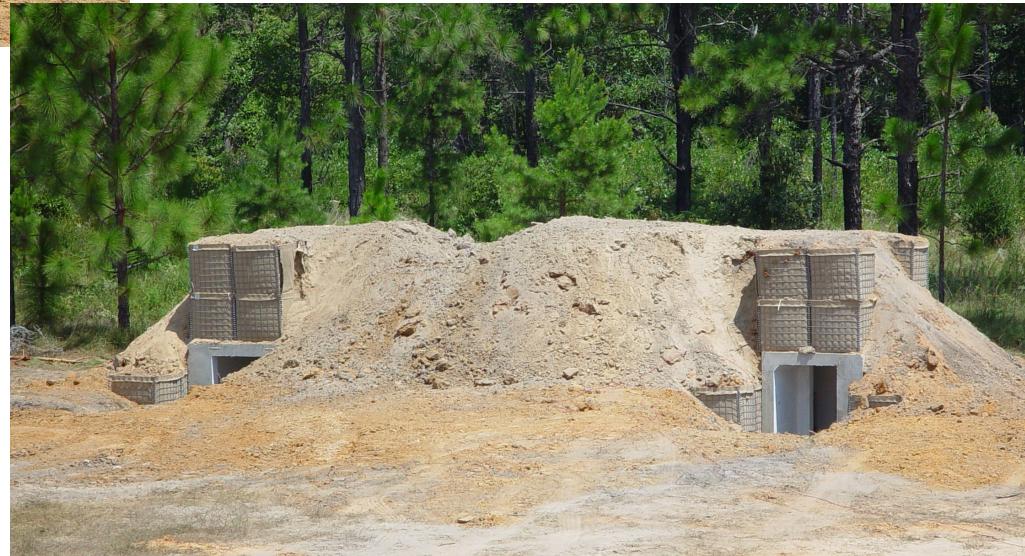
## Shot 1-1

- No effect on concrete section
- Crater dimensions:
  - ✓ diameter = 7'-8"
  - ✓ depth = 2'-2"

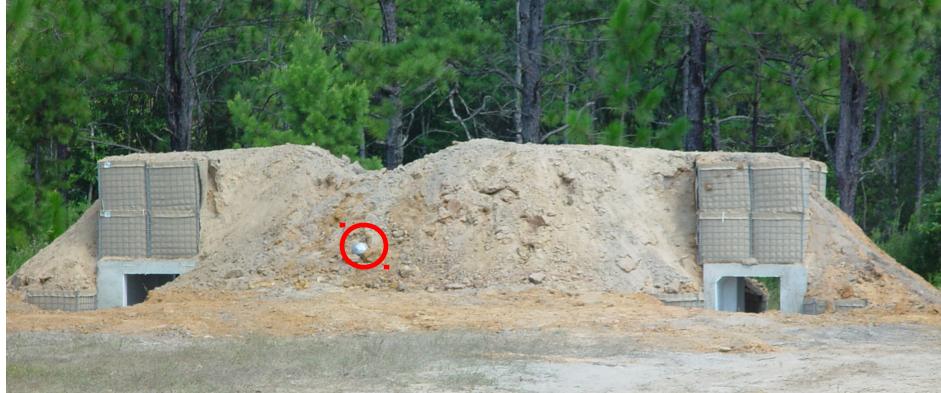
## **Shot 1-2**

- **No effect on concrete section**
- **Crater dimensions:**
  - ✓ **diameter = 7'-11"**

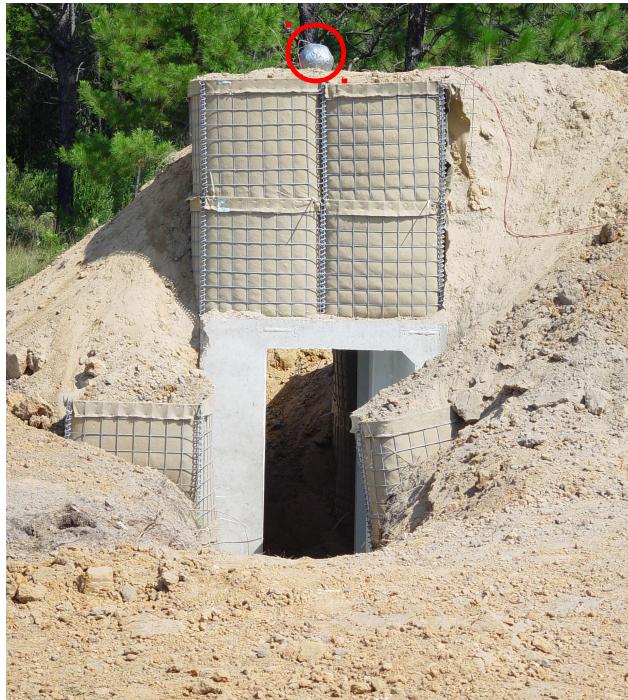
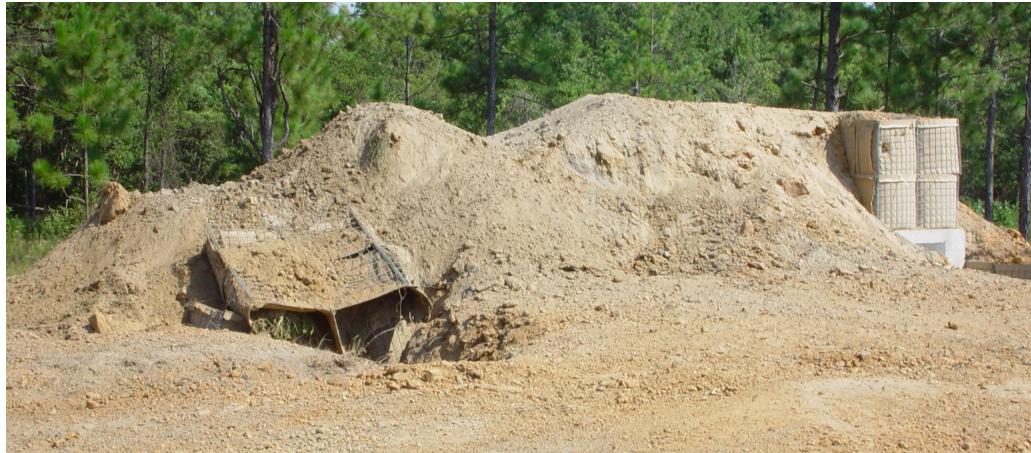
## Shot 1-3

- No effect on concrete section
- Overturned Hesco retaining walls
- Clear egress remained at opposite end

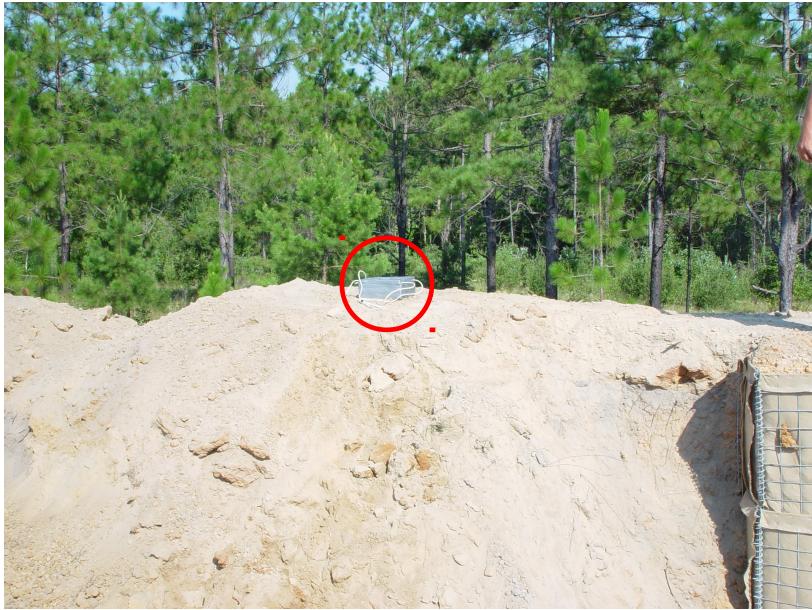
## Shot 1-4

- Induced two flexural cracks in roof; crack widths approx. 1/16<sup>th</sup> inch
- No measurable permanent deflection in roof
- Crater dimensions:
  - ✓ diameter = 11'-6"

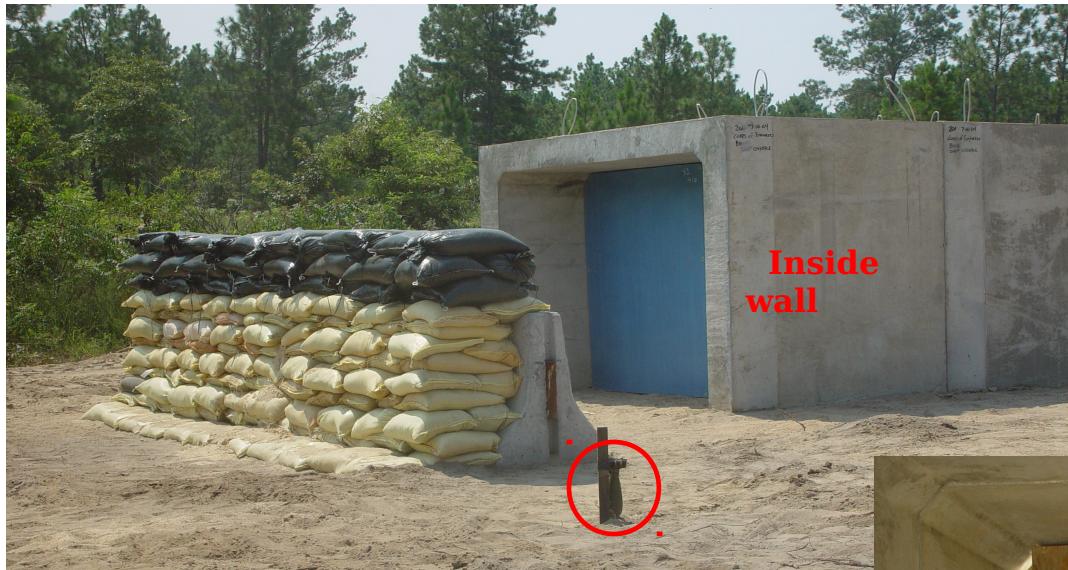
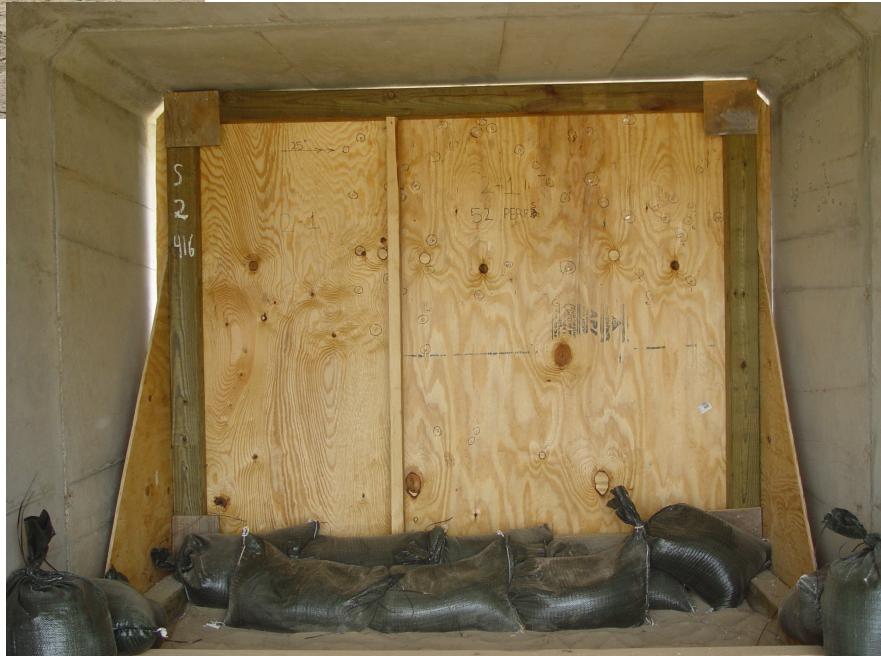
## **Shot 2-1**

- Foam/plywood witness panel hit hundreds of times
- Witness panel plywood perforated 52 times
- No hits observed in witness panel within 19" of inside wall

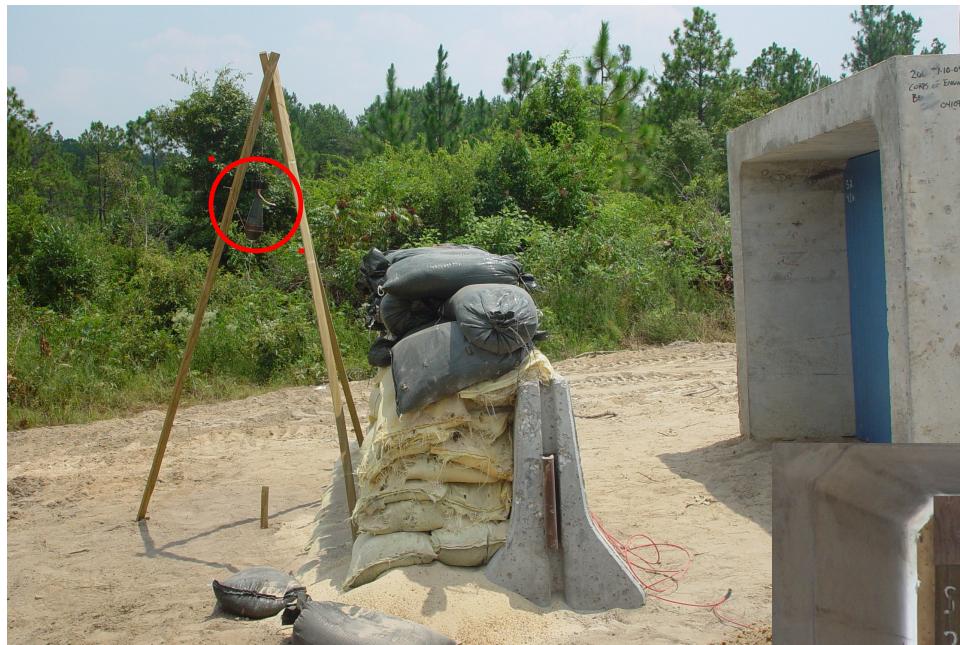
## **Shot 2-2**

- Foam/plywood witness panel hit hundreds of times
- Witness panel plywood perforated 221 times
- No hits observed in witness panel within 14" of ground

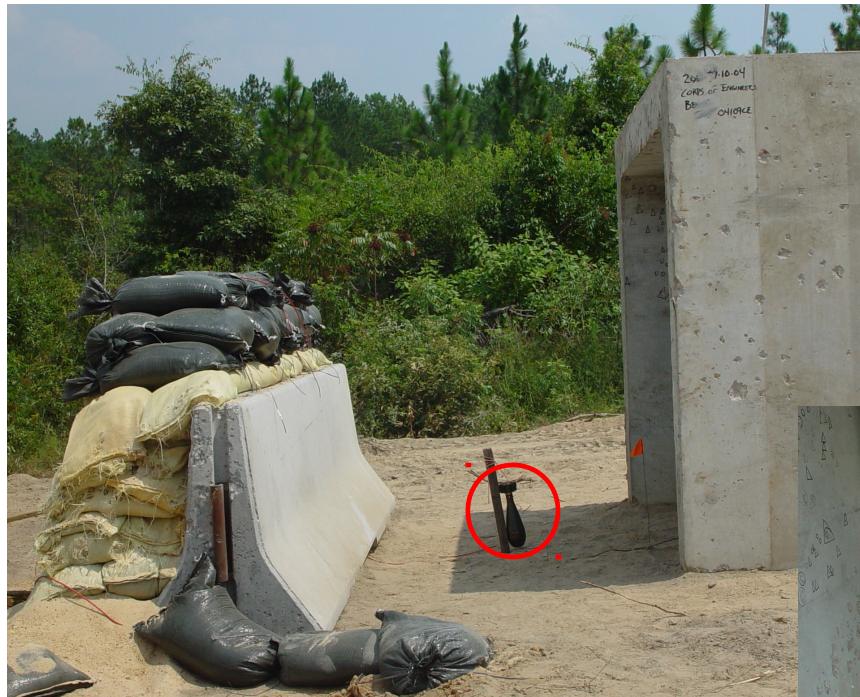
## **Shot 2-3**

- Foam/plywood witness panel destroyed
- Significant damage to inside walls of structure

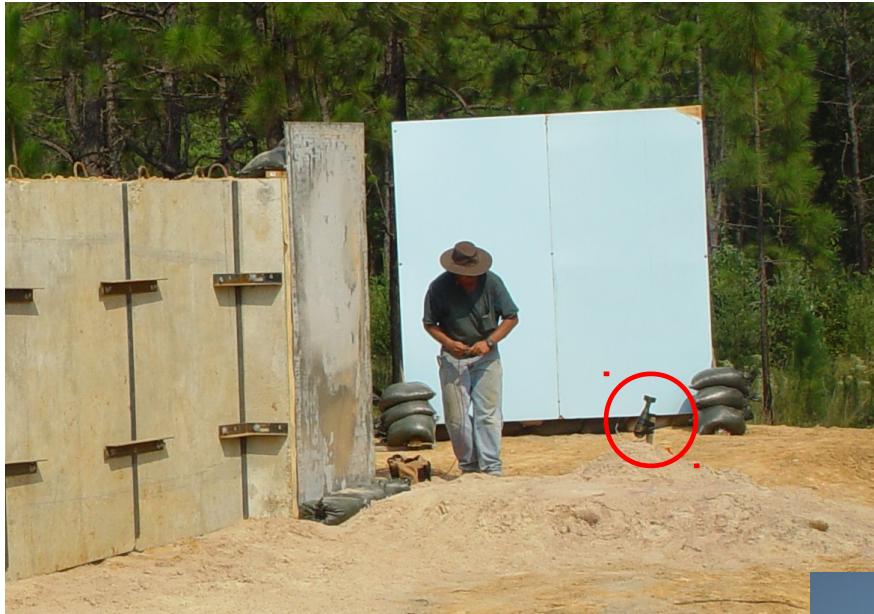
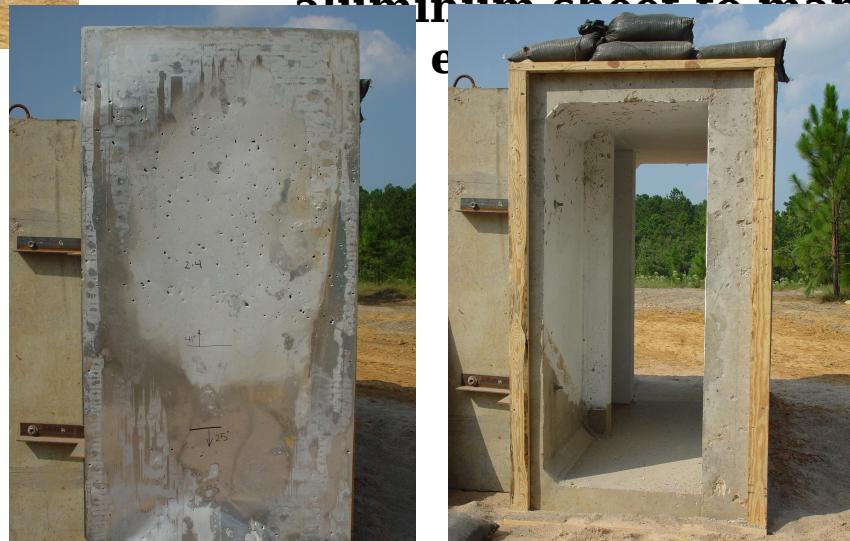
## **Shot 2-4**

- Tremendous number of hits on aluminum panel
- Fragment damage to walls in entryway
- Moderate number of hits on witness panel foam (all secondary debris)

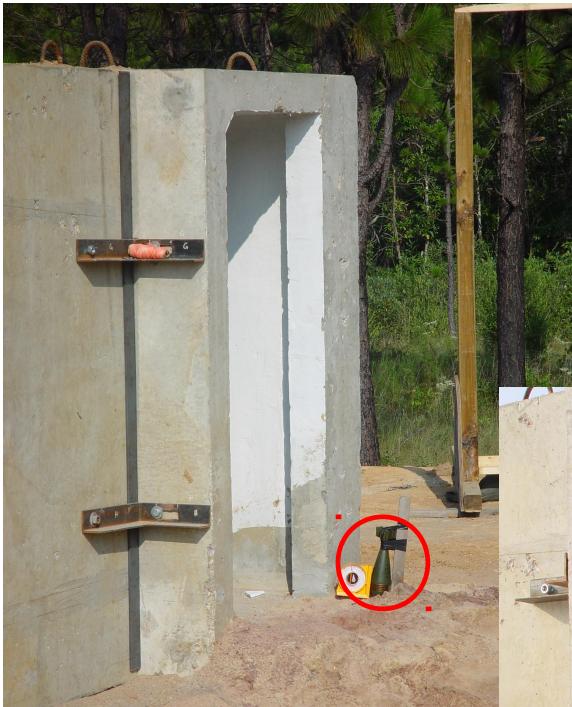
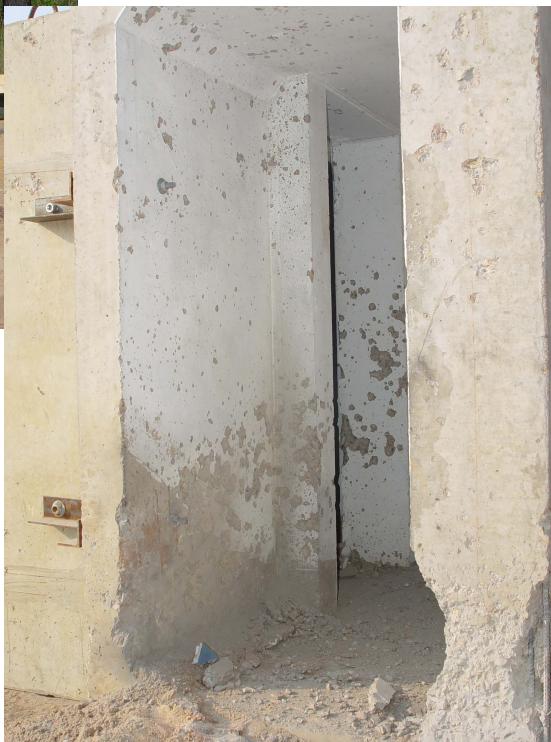
## **Shot 2-5**

- Weapon placed 1' from entrance to bunker
  - Simulating contact detonation on ground
  - Oriented at 10° from normal and at best line-of-fire into bunker
  - No aluminum witness panel
  - Frag damage to walls in entryway
  - Numerous hits on witness panel foam (secondary debris & small frags)
  - No perforation of plywood

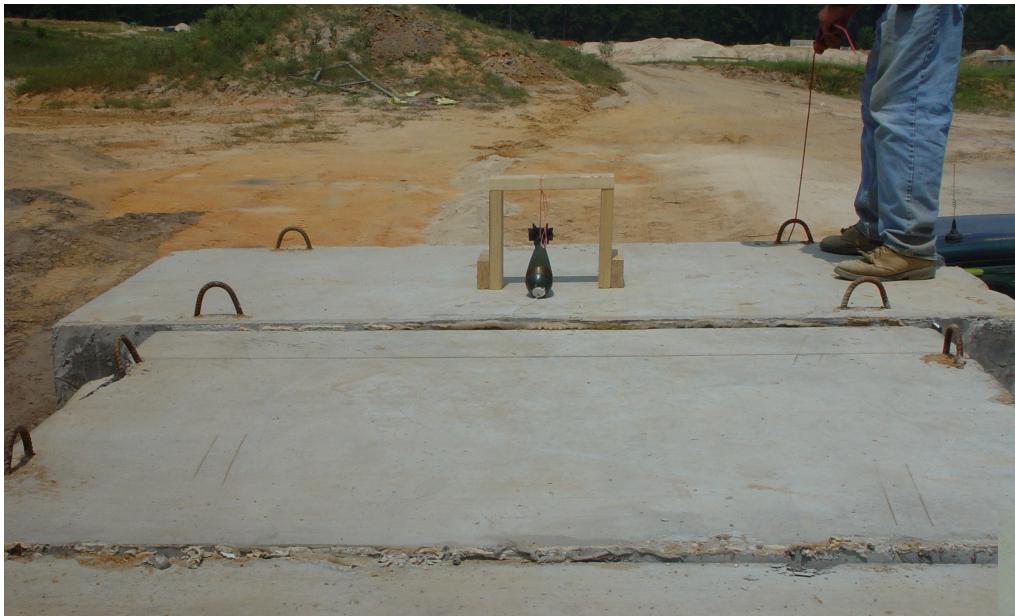
## *Shot 3-1*

- No fragment penetration into structure
- Minor shockwave induced back-face spall
- No perforation of witness panel plywood

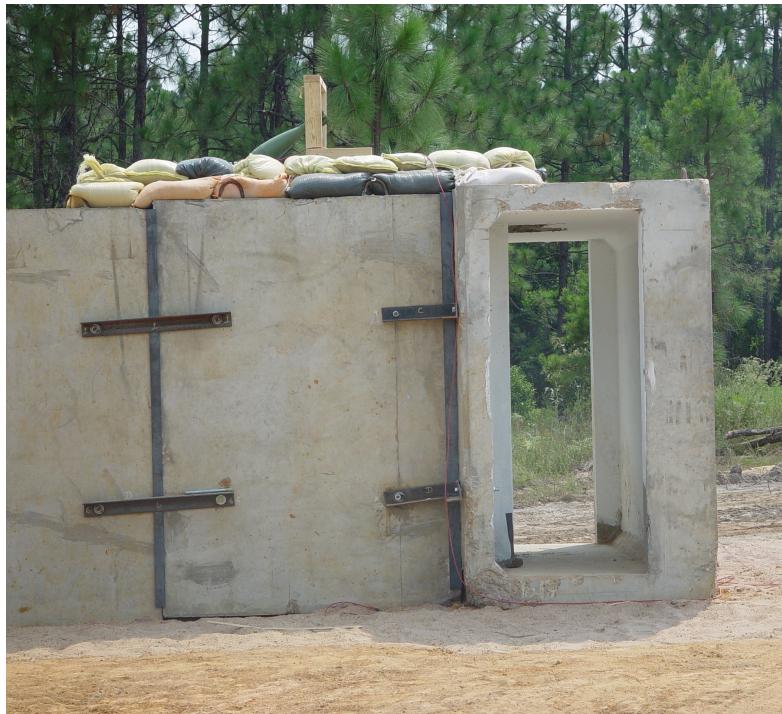
## **Shot 3-2**

- No fragment penetration into structure
- Flexural roof response to blast loading
- Approx. permanent deformation

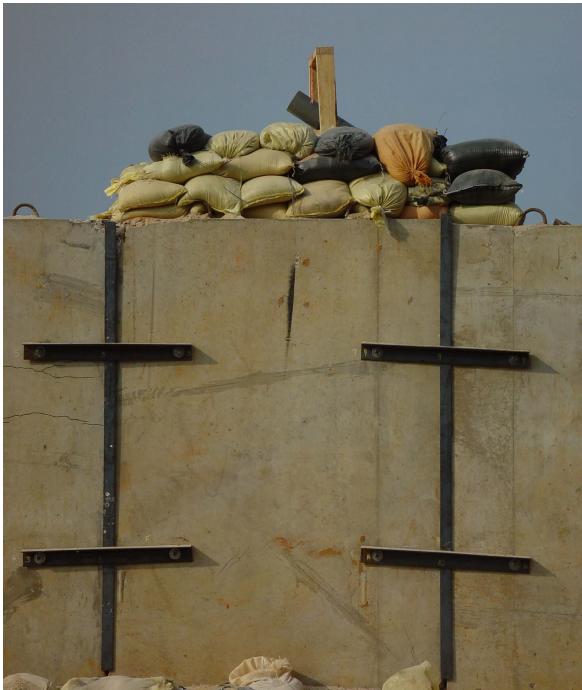
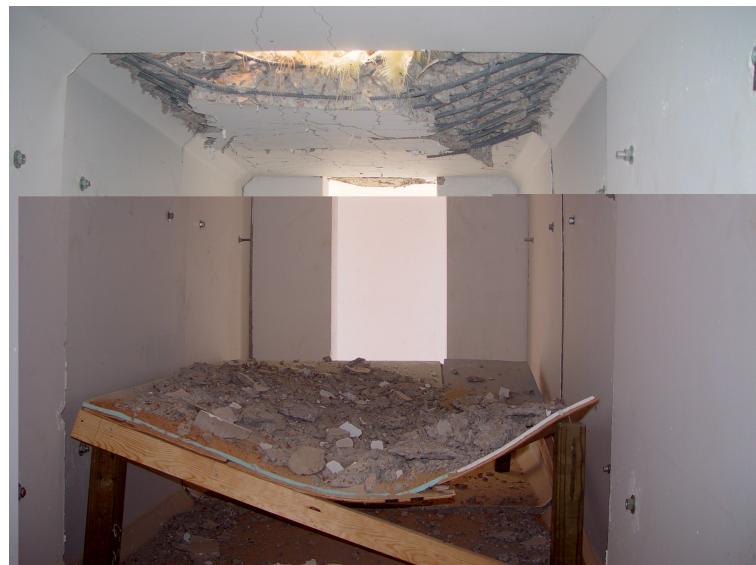
## **Shot 3-3**

- No fragment penetration into structure
- Significant flexural roof response to blast loading
- Approx. permanent deformation = 6"-8"
- Back-face spall due to shock and flexural deformation

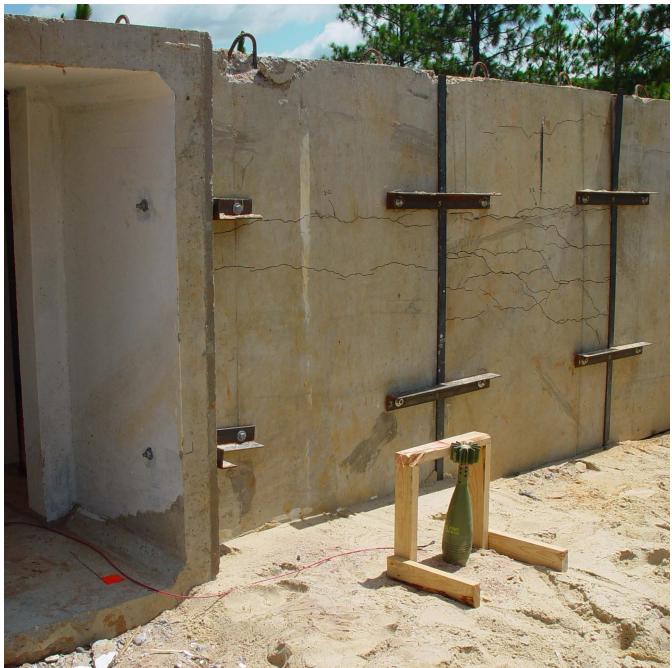
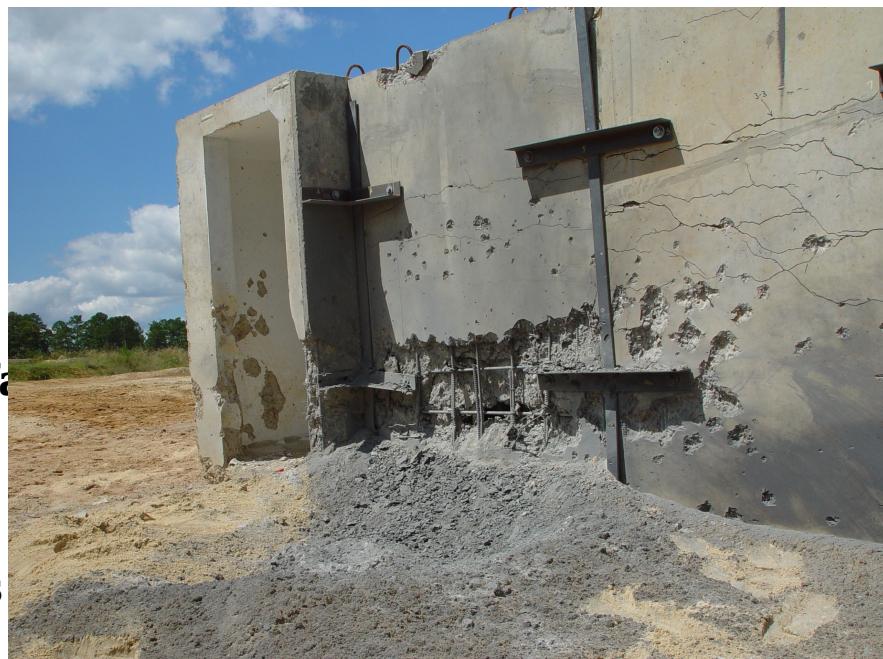
## *Shot 3-4*

- Minor fragment penetration into structure
- Moderate shockwave induced back-face spall
- Approx. 4"x19" breach
- Numerous penetrations into witness panel foam (secondary debris)
